Fixation of a Radius and Ulna Fracture in an Asian Elephant Calf by Using Fibreglass Casts

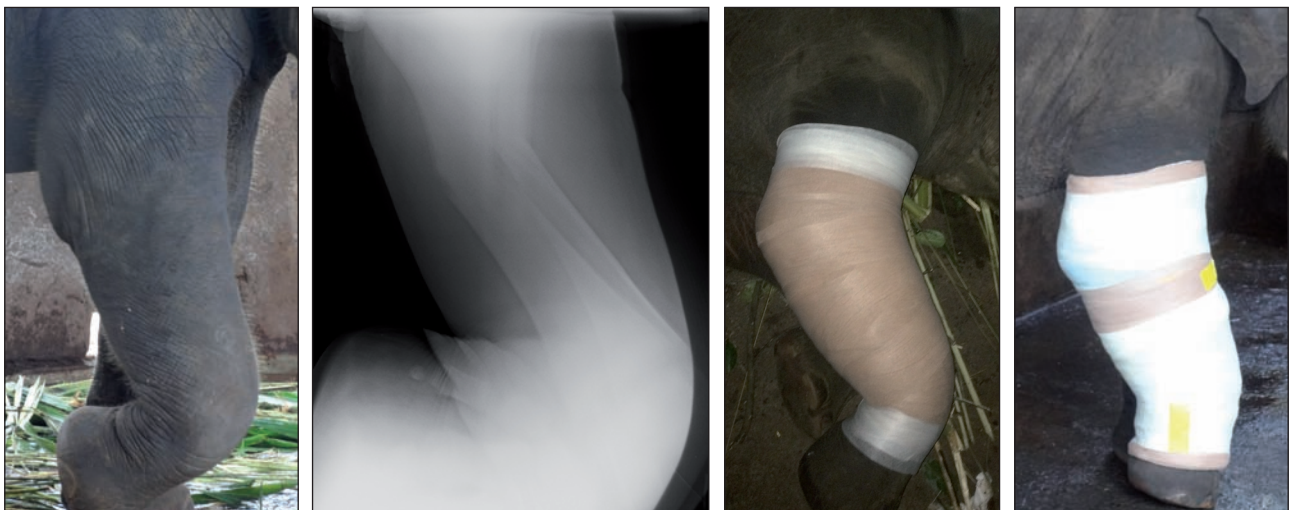
Fig. 1. Swollen leg. **Fig. 2.** Radiograph. **Fig. 3.** Robert Jones bandage. **Fig. 4.** First fibreglass cast

A two-year old male Asian elephant (*Elephas maximus*) calf at the Pinnawala Elephant Orphanage was observed to be limping, favouring his right front leg in the morning of 5th July 2017. The calf was kept untethered with his mother in a separate shed at night and he might have had a fall while attempting to climb on the iron bars of the shed. The limb was noticeably swollen (Fig. 1) from elbow to the carpal joint. Xylazine was administered intramuscularly (Table 1) using a blowpipe and, radiographs taken in the standing position. Sedation was reversed with yohimbine hydrochloride. Radiographs revealed a complete mid-shaft oblique fracture involving both radius and ulna (Fig. 2). Drugs administered consisted of 10 ml of dexamethasone intramuscularly, daily for five days, frusemide 1200 mg with potassium chloride 1800 mg twice a day for 14 days and 10 ml of long acting penicillin at four day intervals for 1 month.

Two days after the incident, the calf was sedated again (Table 1), restrained on lateral recumbency on grass bedding and the trunk connected to a mask supplying oxygen. After thorough scrubbing of the affected leg using povidone iodine and then isopropyl alcohol, a Robert Jones bandage was applied to stabilize the fracture allowing the swelling to be resorbed. Immobilization was obtained by including joints both proximal and distal to the fracture in the bandage (Fig. 3). The bandage included two internal layers of orthopedic cotton padding, two layers of gauze bandage as an intermediate layer and two outer layers of elastic adhesive bandage.

calf was sedated again and the Robert Jones bandage removed. Two layers of orthopaedic cotton padding, two layers of gauze bandage and an external layer of fibreglass bandage (3M™ Scotchcast™ Plus casting tape) was applied (Fig. 4). The Scotchcast hardened within 10 min and the entire casting process took 38 min.

In order to better stabilize the fracture by neutralizing the possible forces of bending, rotation, shortening and distraction, it was decided to apply a fibreglass (3M Scotchcast™) cast. Therefore 7 days after the incident, the

Twenty days after the incident, as the swelling had gradually reduced, the scotch cast slid down on the leg. Therefore after sedating the calf again, while on lateral recumbency on grass bedding, a new fibreglass cast was applied to conform to the measurements after the swelling reduced. After removing the first cast, four custom-made aluminium plates with appropriate curves and bends were placed over the fracture area so that the joints below the elbow in that leg could not be bent (Fig. 5). This procedure required an extended time and two additional doses of xylazine were given (Table 1). The site of fracture was aseptically prepared with povidone iodine and isopropyl alcohol and two layers of orthopaedic cotton padding, then gauze bandage and thereafter a single layer of fibreglass tape, were applied. Four aluminium splints, prepared

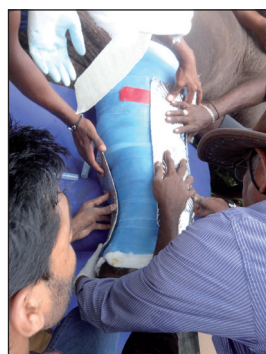
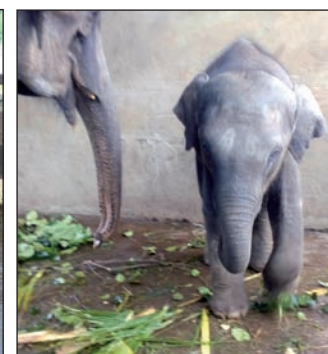
**Fig. 5.** Second fibreglass cast.**Fig. 6.** Third fibreglass cast.**Fig. 7.** Recovered calf.

based on specific measurements of the calf, were placed on the first fibreglass tape layer, and secured with a layer of adhesive plaster. Two layers of fibreglass tape were applied over the splints thereafter. The calf was left sedated for 20 min for hardening of the cast. This fibreglass cast was kept for 47 days.

During removal of the second fibreglass cast with aluminium plates, no complications were observed except for minor pressure wounds. Subsequently, 65 days after the incident, four new custom-made aluminium plates were placed on the new fibreglass cast layers after sedation (Fig. 6). Several additional doses of xylazine were given to obtain satisfactory sedation (Table 1). However the calf did not tolerate this cast and removed it on his own 2 weeks after its application. Repeated sedation required increasing volumes of xylazine as intramuscular or intravenous injections.

Currently, the calf is applying weight on the fractured leg with a mild limp (Fig. 7). To our knowledge this is the first successful use of fibreglass casts, on an elephant calf in Sri Lanka.
